## **WETLAND RESTORATION ACTION PLAN**

### **CATOCTIN MOUNTAIN PARK CHESAPEAKE & OHIO CANAL NATIONAL HISTORICAL PARK HARPERS FERRY NATIONAL HISTORICAL PARK MONOCACY NATIONAL BATTLEFIELD**

**FEBRUARY 2017**

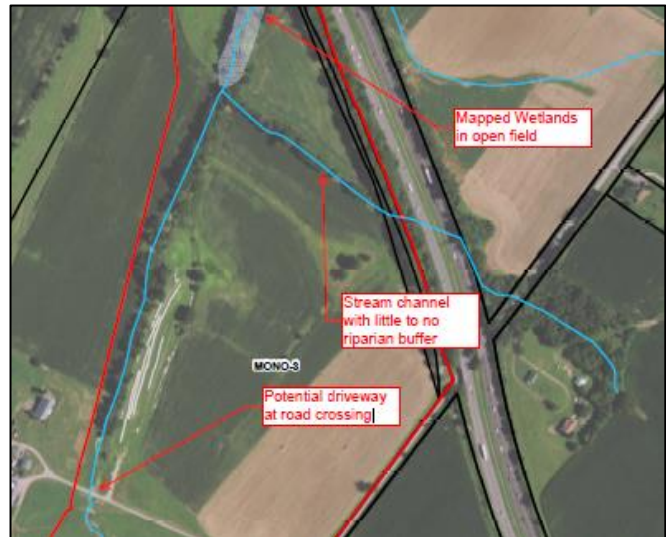
**Initial Screening.** The desktop review was initiated by overlaying the GIS data provided by the NPS onto GIS readily available aerial photographs, and searching for areas within the parks' boundaries where mapped wetlands and streams occurred in open agricultural fields or in areas of known development or disturbance such as road crossings, parking lots, or residential areas along the parks' boundary edges. Typically, areas where mapped wetlands or streams appeared to occur adjacent to impacted areas were identified (example 1). In addition to mapped wetlands/streams provided by the NPS or mapped by the NWI, an aerial review of the entire park boundaries of all four parks was conducted to identify potential wetlands observed on current and recent aerials (between 2012 - 2015) that may not have been included in the mapped data.

*Example 1: Initial Review of Mapped Resources at MONO.*
