Preliminary Assessment Prepared for:

Preliminary Assessment
27 Abandoned Mineral Lands Sites
Death Valley National Park
Inyo and San Bernardino Counties, California and Nye County, Nevada

November 21, 2014

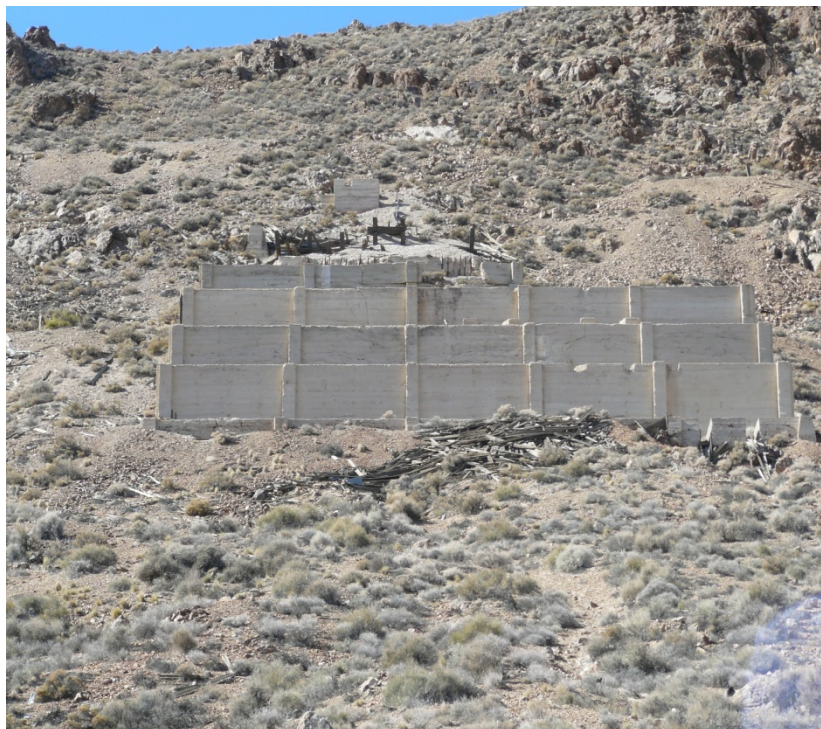
The PA inspection of Homestake Mill, also known as the Homestake-King Mill, was conducted on February 13, 2014. Field notes are included in **Appendix D**. Photographs showing site features and current environmental conditions are presented in **Appendix C1**. **Figure 3-1** shows the topographic features in the vicinity of the site, and indicates the location of the mill. Site features are depicted on **Figure 3-2** and include:

The mill site contains a series of five, reinforced concrete foundations that are between 66 and 100 feet long, 3 feet thick at the base, and up to 16 feet high. The structures are located on a steep slope (**Photo C1-2**). Floors of the mill rooms remain with many machinery and vat foundations and building debris. The former mill site covers an approximate 100-foot by 150-foot area. A very large abandoned open pit mine, named Gold Bar, is located to the west of Homestake Mill and has cyanide leach mounds to the south, outside the park boundary (**Figure 3-1**). The Gold Bar Mine was a more recent operation that employed a cyanide heap leaching process. Homestake Mill covers approximately 5 acres and is visited by approximately 400 people per year. The mine was determined to be eligible for the National Register of Historic Places in 1981⁴⁴.

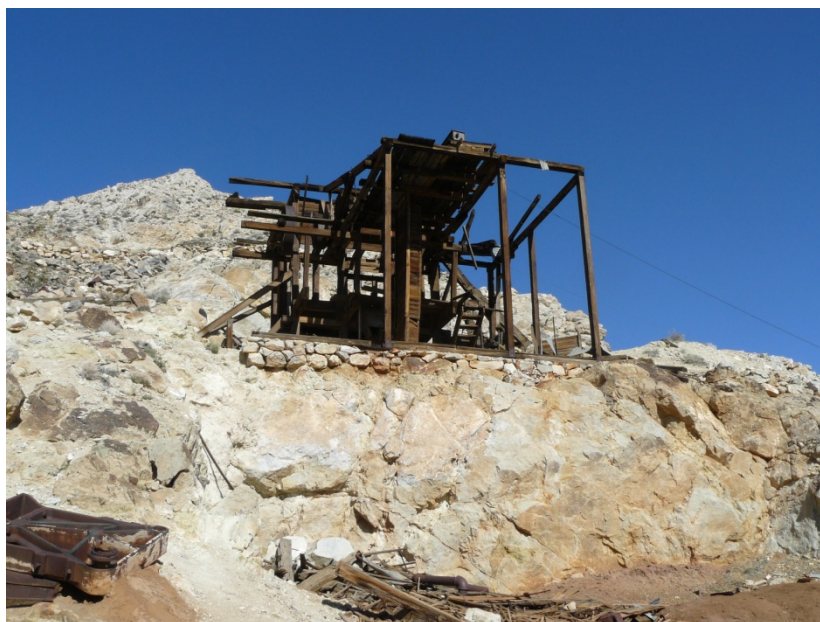
The PA inspection of Lost Burro Mine and Mill was conducted on February 19, 2014. Field notes are included in **Appendix D**. Photographs showing site features and current environmental conditions are presented in **Appendix C2**. **Figure 4-1** shows the topographic features in the vicinity of the site, and indicates the locations of the mill and mine, cyanide processing area, and extent of tailings. Site features are depicted on **Figure 4-2** and include:

Observation of the mill tailings noted during the PA site visit indicated the tailings are located in five distinct areas throughout the site. The total amount of mill tailings observed on site is approximately 2,450 cubic yards. **Figures 4-1 and 4-2** show the locations of the mill tailings and the erosion and transport paths of the tailings eroding downstream. Photographs of the tailings deposits are also provided (**Photos C2-4, C2-5, and C2-6**). The preliminary COCs at the site include cyanide and metals. A site inspection in 2002 reported that visitors were camping on areas where cyanide waste remained from the ore processing⁵⁴. The report also noted that visitors were parking and camping in the historic housing area.

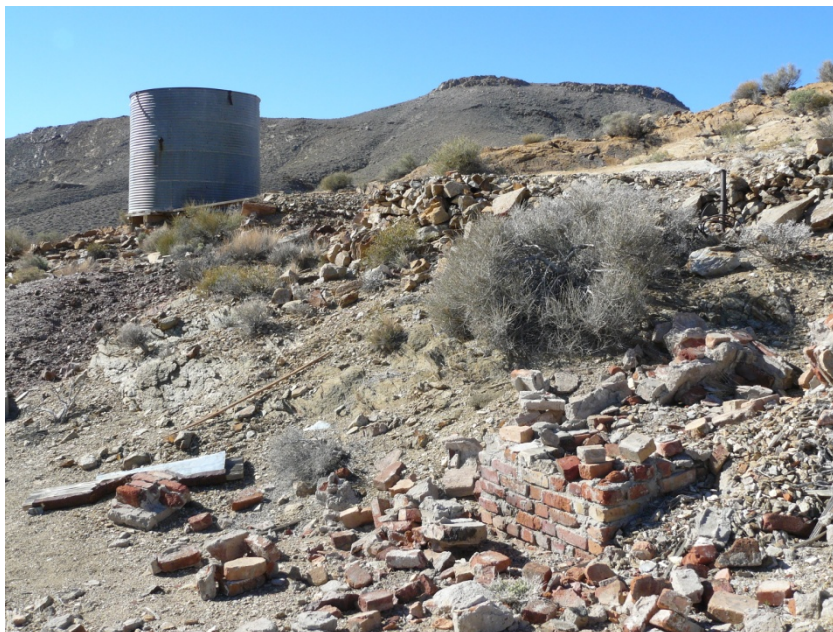
The PA inspection of Crowell Mercury Mill was conducted on March 8, 2014. Field notes are included in **Appendix D**. Photographs showing site features, layout, and current environmental conditions are presented in **Appendix C3**. **Figure 5-1** shows the topographic features in the vicinity of the site, and indicates the locations of the mill, and extent of tailings. Site features are depicted on **Figure 5-2** and include:

Remains of the ore processing equipment include the large galvanized tank and brick foundations. Mill tails have accumulated in and around the mill foundation and in two piles on the southeast side of the site (**Figure 5-1** and **Figure 5-2**). The tailings in and around the brick retort ruins are reddish-grayish (ashen) in color, have coarse-gravel grain size, and an estimated volume of approximately 50 cubic yards (**Photo C3-7**). The mill tailings on the southeast side of the site consist of two separate piles of tailings with an estimated total volume of 200 cubic yards. The larger pile contains an ashen color coarse-grain material and the smaller pile of light pink fine-grain material (**Photo C3-4 and C3-10**). Over the years the tailings have eroded and are migrating downslope in small quantity. The preliminary COCs at this site are metals.

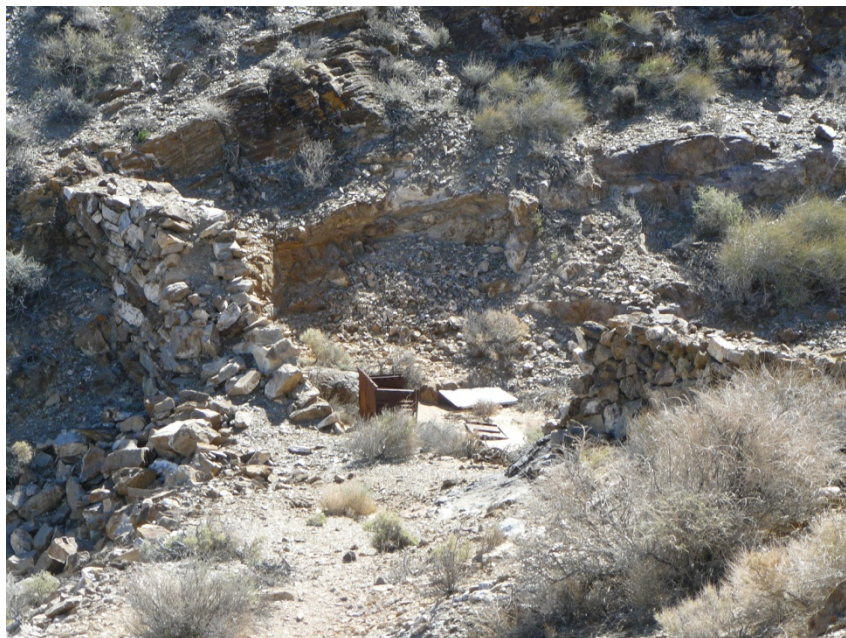
The PA inspection of Lane Mill was conducted on March 8, 2014. Field notes are included in **Appendix D**. Photographs showing site features and current environmental conditions are presented in **Appendix C4**. **Figure 6-1** shows the site layout and topographic features in the vicinity of the site, and indicates the locations of the mill and mine, cyanide processing area, and extent of tailings. Site features are depicted on **Figure 6-2** and include:

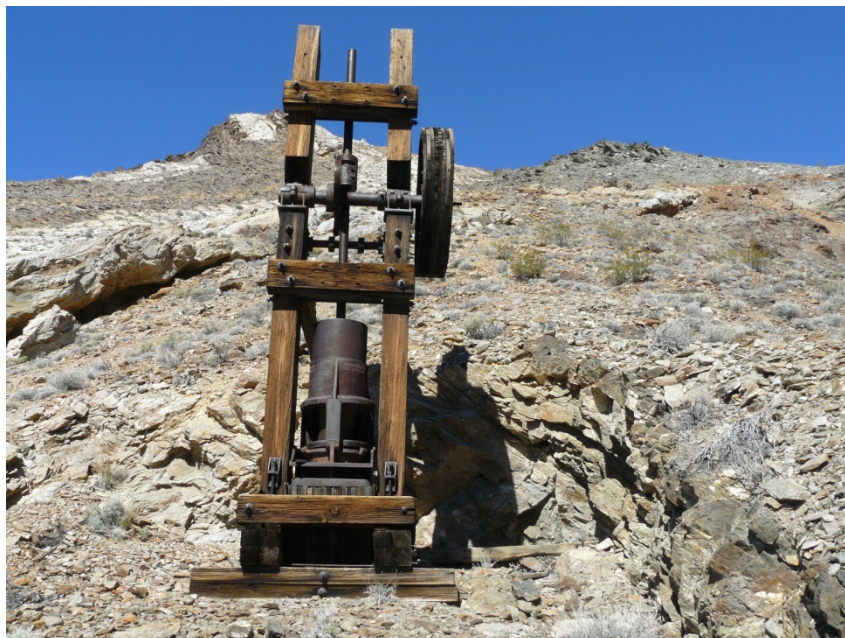
The PA inspection of Franklin Mill was conducted on March 8, 2014. Field notes are included in **Appendix D**. Photographs showing site features and current environmental conditions are presented in **Appendix C5**. **Figure 7-1** shows the topographic features in the vicinity of the site, and indicates the location of the mill. Site features are depicted on **Figure 7-2** and include:

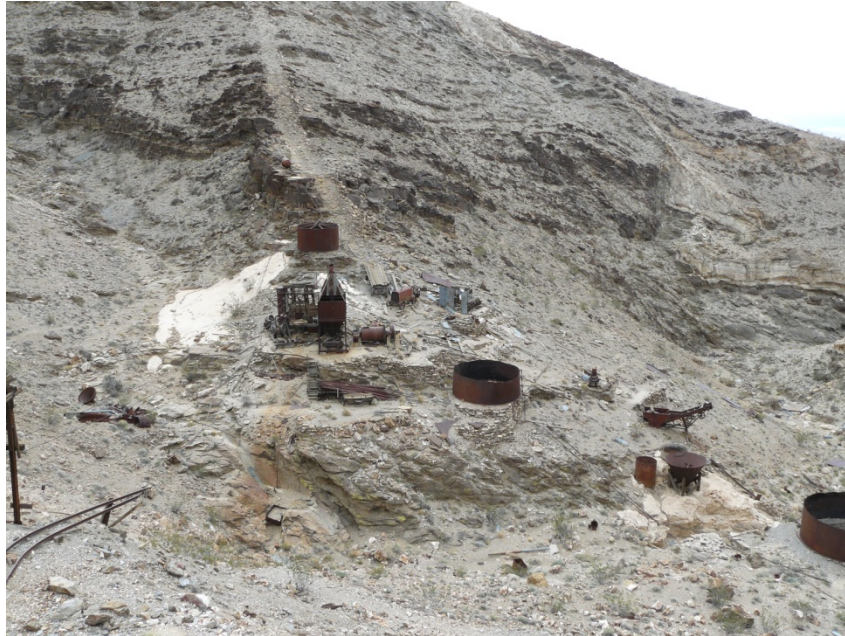
The PA site inspection of the Big Bell Mine and Mill was conducted on February 18, 2014. Field notes are included in **Appendix D**. Photographs showing site features and current environmental conditions are presented in **Appendix C6**. **Figure 8-1** shows the topographic features in the vicinity of the site, and indicates the locations of the mill and mine, cyanide processing area, and extent of tailings. Site features are depicted on **Figure 8-2** and include:

Big Bell Mine and Mill site is located 12 miles southwest of Beatty, Nevada, in the Funeral Mountains (Latitude 36.69283°, Longitude -116.89609°) at an elevation of approximately 3,600 feet above sea level. **Figures 8-1** and **8-2** show the site layout and site features and **Appendix C6** show photographs taken during the site inspection. The site is accessed via seven miles of rough four-wheel drive road, followed by a steep one mile hike that descends approximately 2,000 feet. This site is located in the Keane Wonder Mine closure area. A sign at the parking area explains the closure, but no physical barriers exist. The site was closed to the public and non-essential employees in 2008; however, it is estimated that the site is visited by approximately 100 people per year.

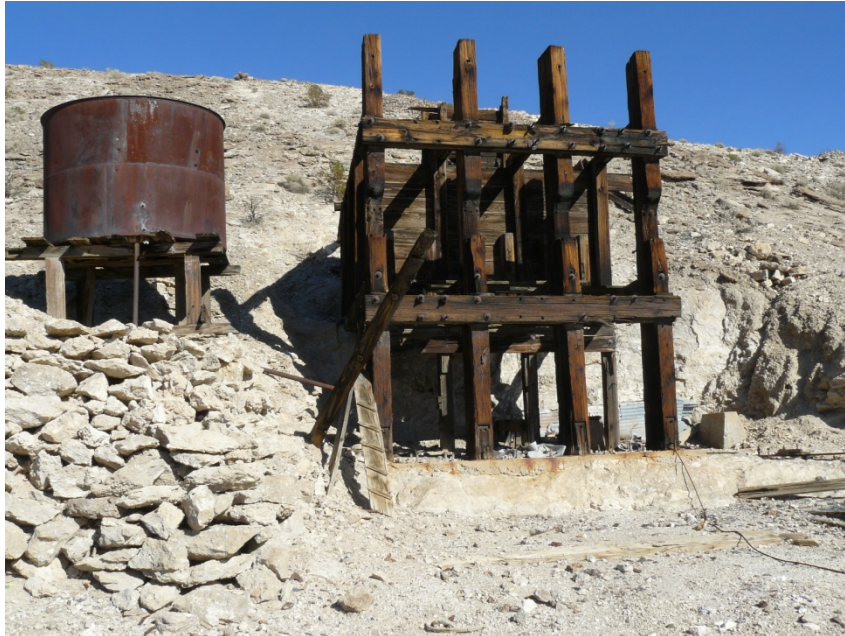
The PA inspection of the Cyty's Mill site was conducted on January 8, 2014. Field notes are included in **Appendix D**. Photographs showing site features and current environmental conditions are presented in **Appendix C7**. **Figure 9-1** shows the topographic features in the vicinity of the site, and indicates the locations of the mill, cyanide processing area, and extent of tailings. Site features are depicted on **Figure 9-2** and include:

Cyty's Mine is located at the western slope of the Funeral Mountains in the Amargosa Range, on the eastern side of Death Valley and located approximately one mile northwest of the Keane Wonder Mine (**Figures 9-1**). Access to the site is via a two-mile graded gravel road, which is currently closed to the public, followed by a one mile hike. The site covers less than two acres on the western slope of the Funeral Mountains. The remains of a three-stamp mill and a cabin are approximately 100 feet upgradient to mill tailings as shown in **Photos C7-17** and **C7-20**. Mill tailings are located at the base of the mill. Two cisterns and numerous prospect pits are located in southern section of the site. **Photos C7-12** and **C7-13** in **Appendix C7** show the small springs and associated cisterns near the mill.

Cyanide was historically used at the site to extract gold from the milled ore. The study area includes the stamp mill, the possible cyanide processing area, and the tailings deposits (**Figure 9-1**). Mill tailings generated after using cyanide extraction processes remain on site and are located in what is believed to be the cyanide process area and downslope. The tailings pile contains approximately 20 cubic yards of fine-grained, pink tailings. The tailings have migrated approximately 100 feet down slope from the historic cabin (**Photo C7-21**). During the site inspection, tailings did not appear to be migrating downslope in any significant volume. Based on operational history and information gathered during the PA, the preliminary COCs for the site are cyanide and metals.

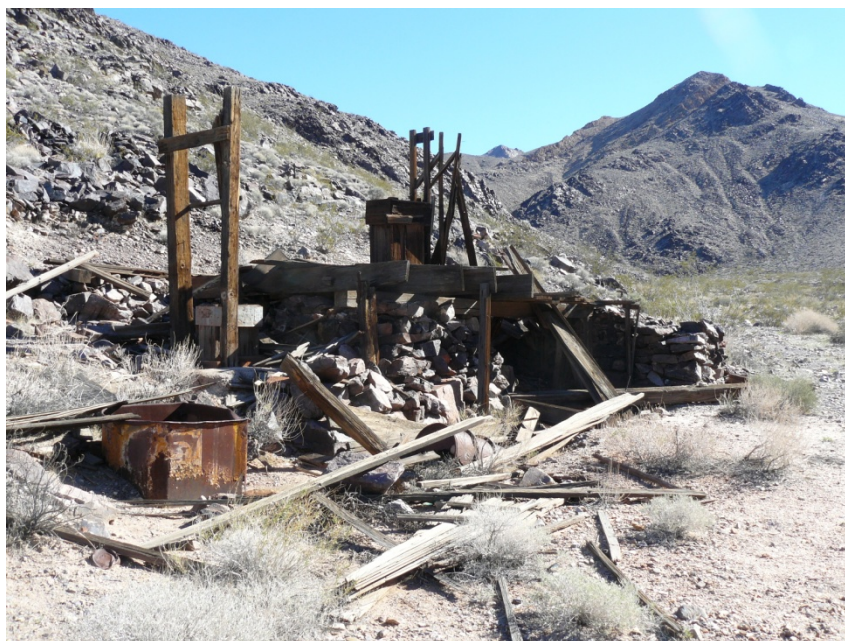
The PA inspection of the Gold Grotto Mine and Mill site was conducted on March 8, 2014. Field notes are included in **Appendix D**. Photographs showing site features and current environmental conditions are presented in **Appendix C8**. **Figure 10-1** shows the topographic features in the vicinity of the site, and indicates the locations of the mill, processing area, and extent of tailings. Site features are depicted on **Figure 10-2** and include:

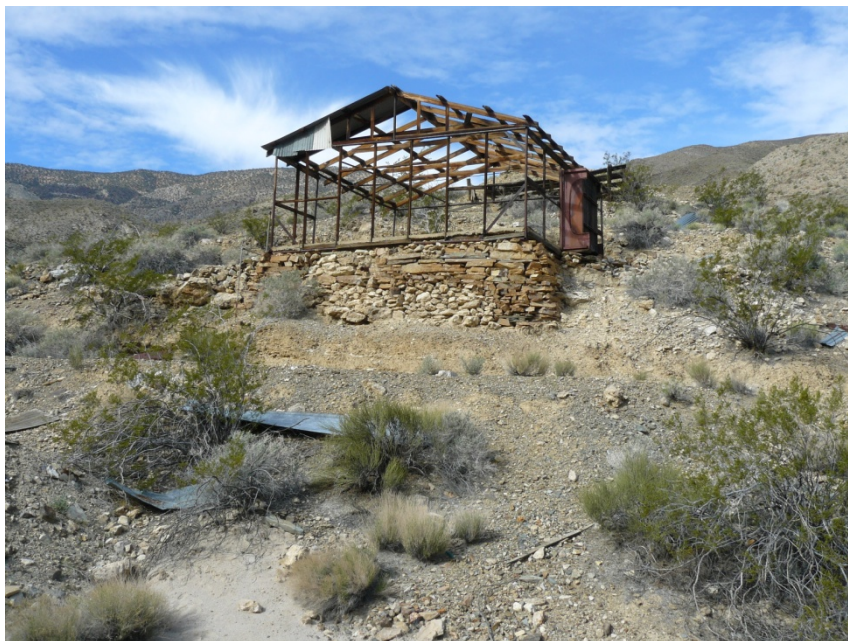
The PA inspection of the Broken Pick Mill was conducted on March 9, 2014. Field notes are included in **Appendix D**. Photographs showing site features and current environmental conditions are presented in **Appendix C9**. **Figure 11-1** shows the topographic features in the vicinity of the site, and indicates the locations of the mill, cyanide processing area, and extent of tailings. Site features are depicted on **Figure 11-2** and include:

location and site features are shown on **Figures 11-1** and **11-2** and site photographs are shown in **Appendix C9**.

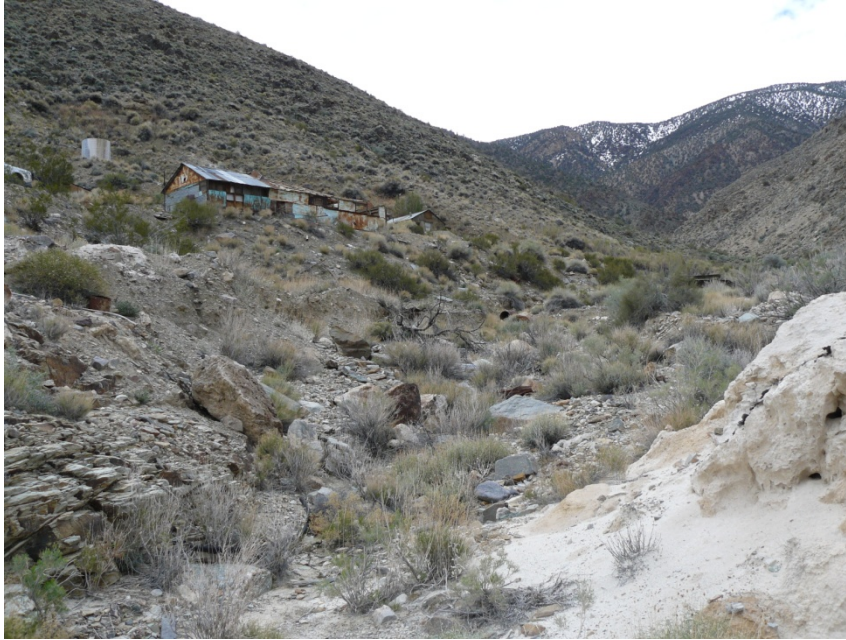
The PA inspection of Morning Glory Mill was conducted on March 9, 2014. Field notes are included in **Appendix D**. Photographs showing site features and current environmental conditions are presented in **Appendix C10**. **Figure 12-1** shows the topographic features in the vicinity of the site, and indicates the locations of the mill, cyanide processing area, and extent of tailings. Site features are depicted on **Figure 12-2** and include:

Morning Glory Mill is located 15 miles southwest of Furnace Creek, California, in the south fork of Trail Canyon Road (Latitude 36.30281°, Longitude -117.04834°) at an elevation of approximately 4286, feet above sea level. This site is accessed at the end of a rough four-wheel drive road approximately 11 miles from the junction of West Side Road and Trail Canyon Road. Morning Glory mine is located one mile southwest of Broken Pick mill. This site is popular for visitors who enjoy four-wheel drive roads and the site is visited by approximately 1,000 people per year. The site covers an area of approximately 3 acres located at the base of a canyon that winds through the steep eastern front of the Panamint Mountain Range. During rain events water drains to the north then east into Death Valley. The closest residents are in Furnace Creek approximately 14 miles northeast of the site. **Figure 12-1** shows the

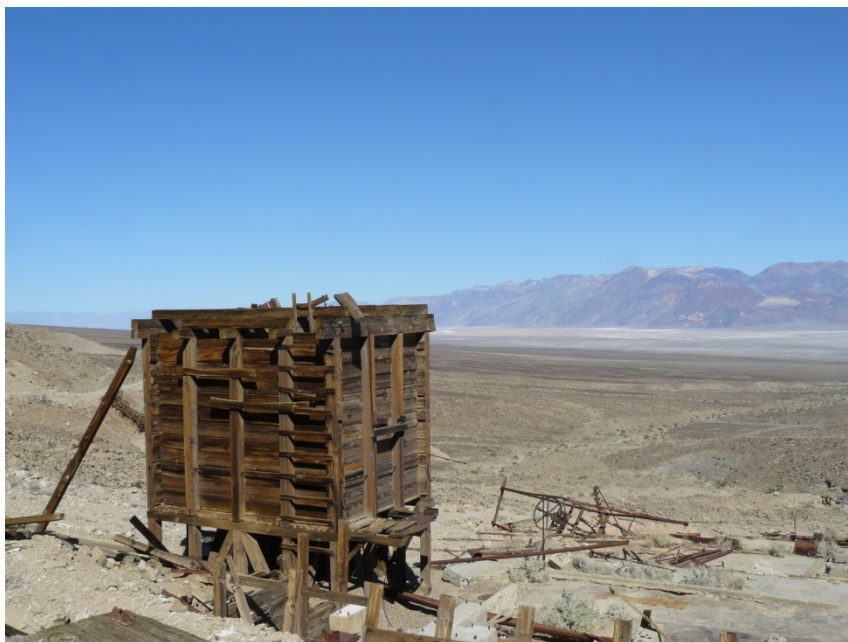
The PA inspection of the Queen of Sheba site was conducted on February 16, 2014. Field notes are included in **Appendix D**. Photographs showing site features and current environmental conditions are presented in **Appendix C11**. **Figure 13-1** shows the topographic features in the vicinity of the site, and indicates the locations of the mill and mine, possible cyanide processing area, and extent of tailings. Site features are depicted on **Figure 13-2** and include:

access road leading to the site and there are two water storage tanks near the well (**Figure 13-1, Photo C11-1**). The well contains non-potable salt water which was used to operate the mill.

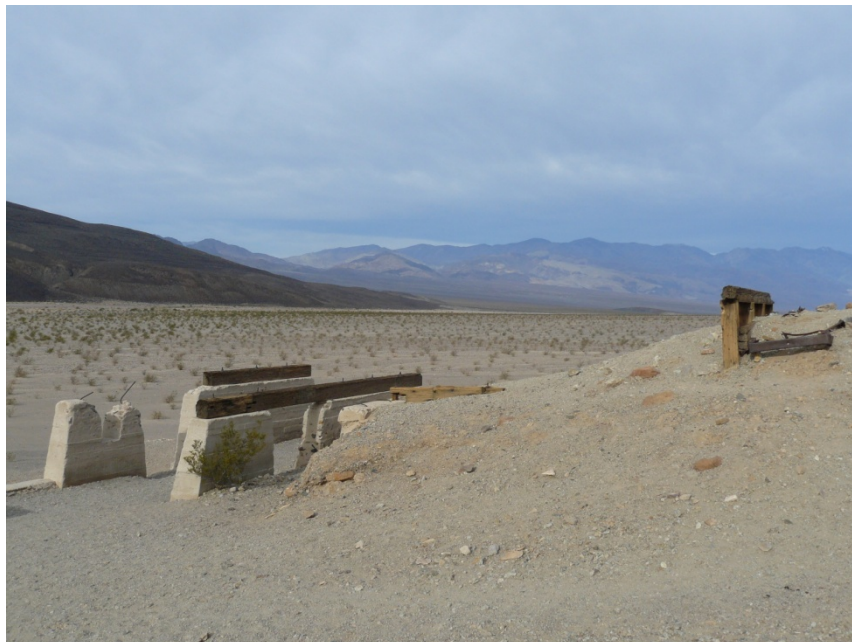
The PA inspection of the Ashford Mill site was conducted on February 15, 2014. Field notes are included in **Appendix D**. Photographs showing site features and current environmental conditions are presented in **Appendix C12**. **Figure 14-1** shows the topographic features in the vicinity of the site, and indicates the locations of the mill, processing area, and extent of tailings. Site features are depicted on **Figure 14-2** and include:
