**Cape Hatteras National Seashore  
North Carolina**

**Finding of No Significant Impact  
Ocracoke Light Station Rehabilitation Project Environmental  
Assessment**

**PROGRAMMATIC AGREEMENT  
AMONG THE U.S. DEPARTMENT OF INTERIOR, NATIONAL PARK SERVICE,  
THE NORTH CAROLINA STATE HISTORIC PRESERVATION OFFICER,  
AND THE ADVISORY COUNCIL ON HISTORIC PRESERVATION,  
FOR THE REHABILITATION OF AND FLOOD ADAPTATION MEASURES AT THE  
OCRACOKE LIGHT STATION  
CAPE HATTERAS NATIONAL SEASHORE,  
HYDE COUNTY, NORTH CAROLINA**

**ATTACHMENT D – Schematic Design Documents for Alternative B\***

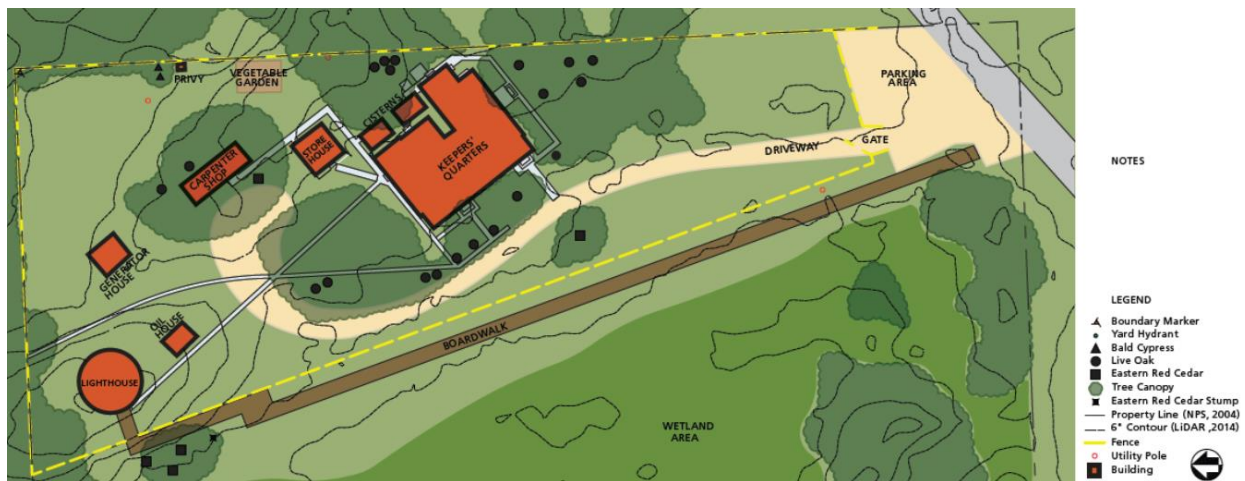
A. Existing structures and vegetation (Note: Some current locations are not shown; slight movement occurred due to prior storm damage, as is noted in Schematic Design)

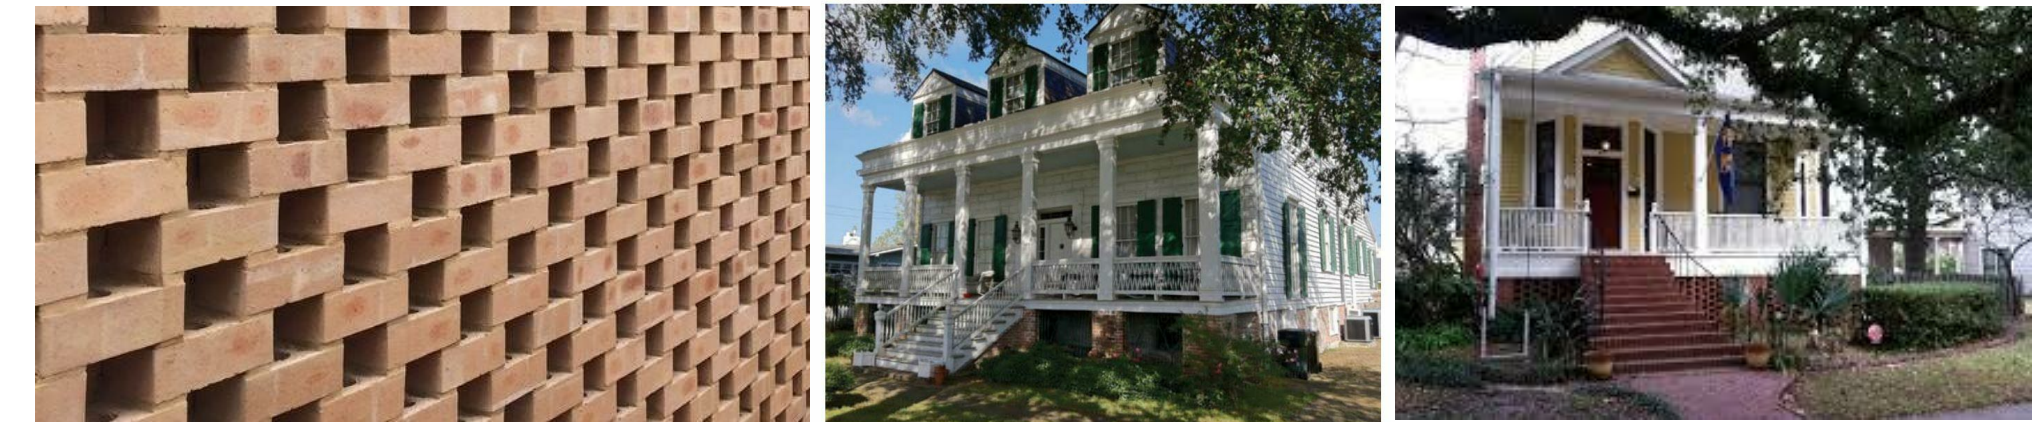
DESIGN TO BE FURTHER DEVELOPED DURING DESIGN DEVELOPMENT PHASE AND SHALL COMPLY WITH SECRETARY OF THE INTERIOR'S STANDARDS AND GUIDELINES FOR REHABILITATION

1. PERFORATED BRICK SCREENING

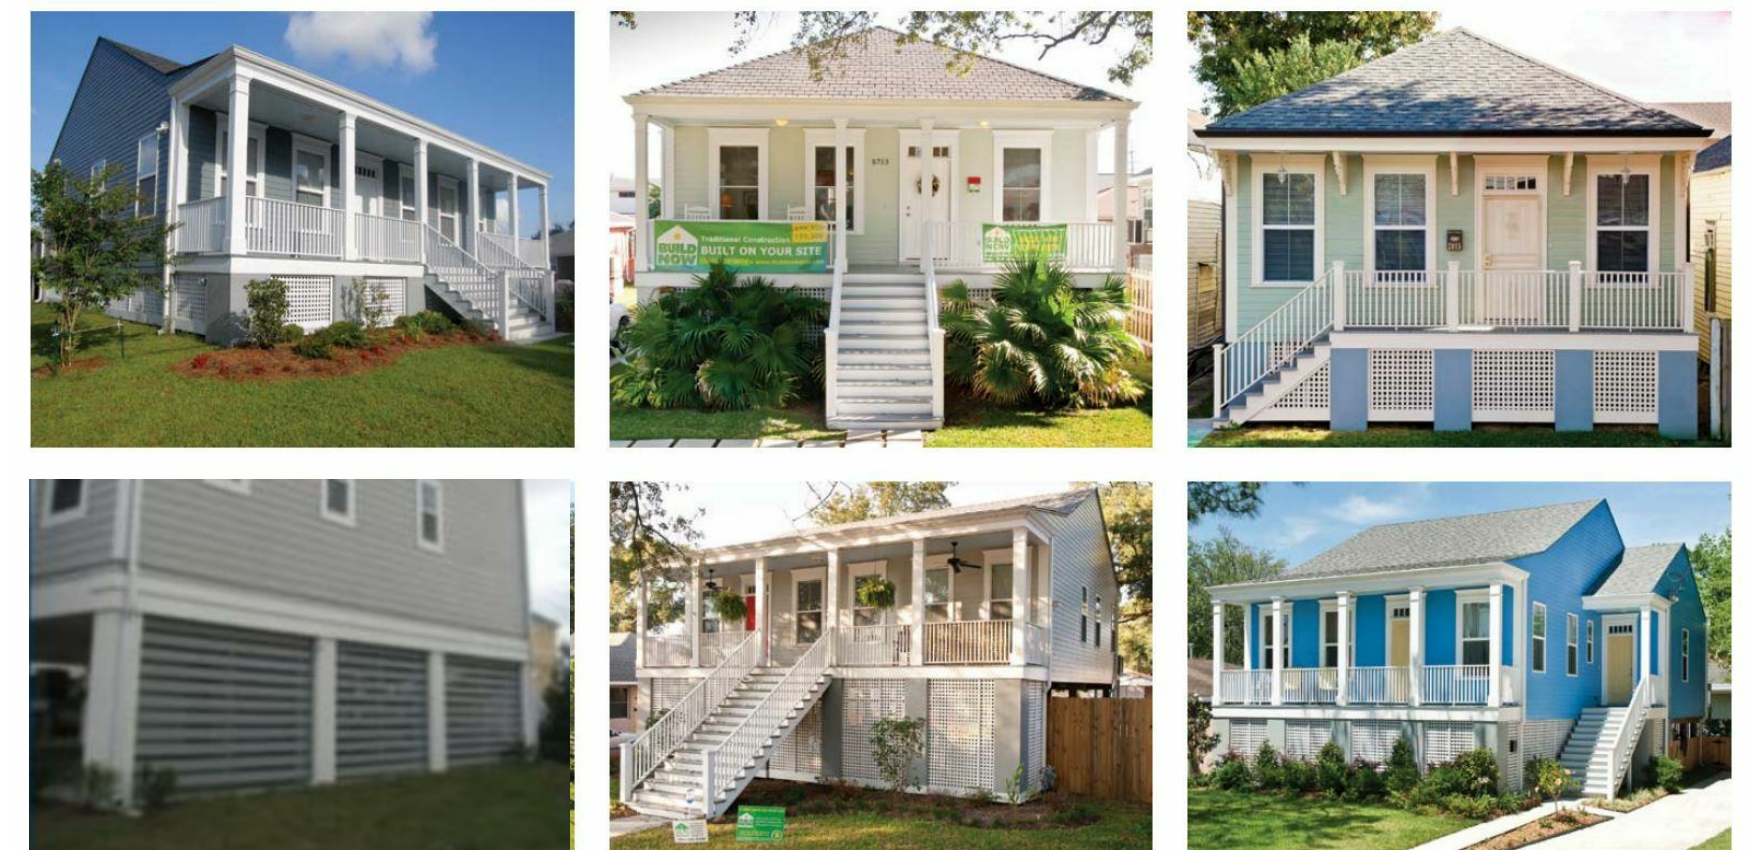
2. CUSTOM WOOD LATTICE (ORTHAGONAL PATTERN)

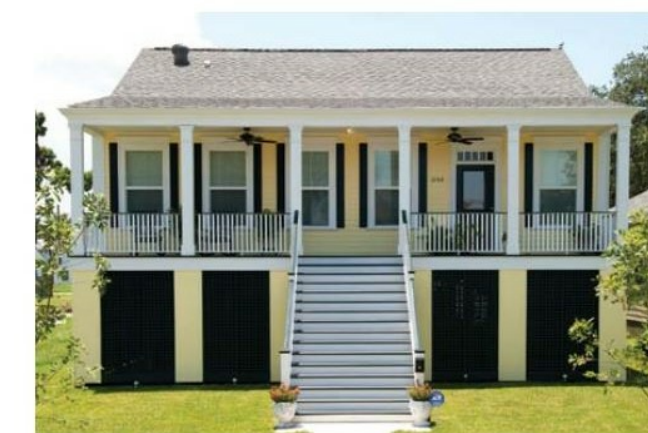
3. SOLID BREAKAWAY PANEL
