## Chapter 2

### The Alternatives

## **CHAPTER 2: THE ALTERNATIVES**

## 2.1 Project Alternatives

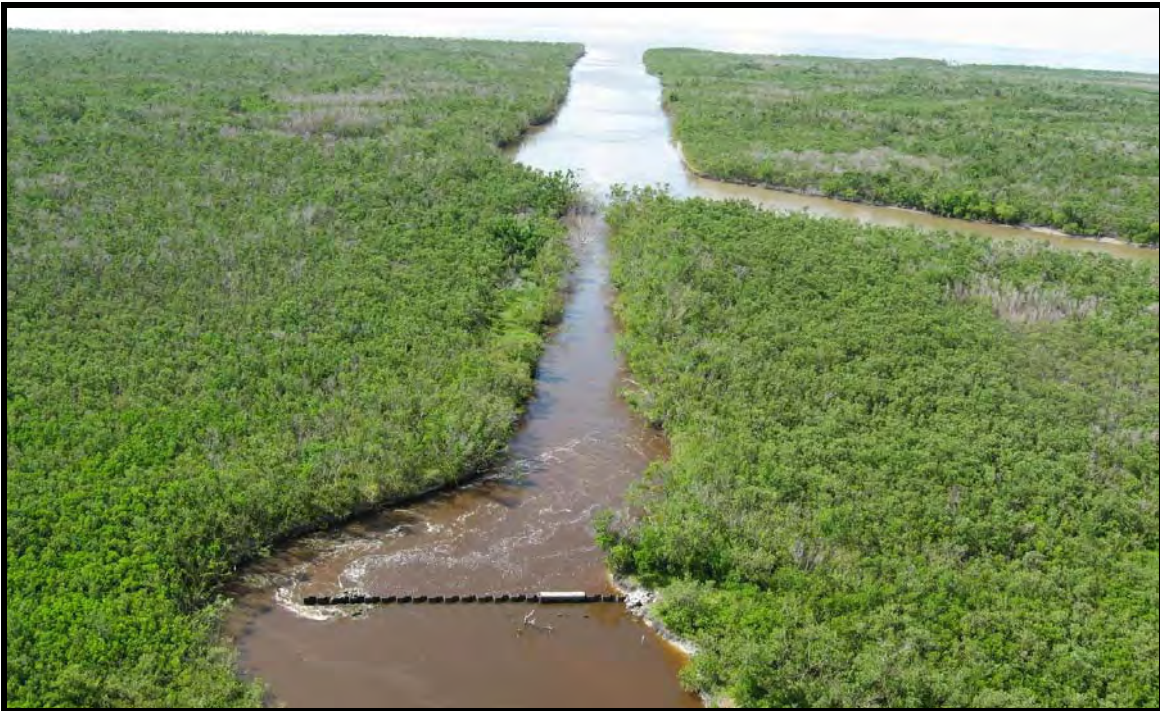
***Figure 2.1 – East Cape Extension Canal Failed Dam Site (Facing South)***

Based on the preliminary analysis, internal scoping with the NPS, and the public input related to the proposed project, the following alternatives were carried forward for analysis in the EA. As reference, alternative drawings (Figures 2.7 through 2.16), alternative comparison tables (Tables 2.2 and 2.3) and Class C Cost Estimates (Tables 2.4 through 2.11) for the East Cape Extension and Homestead canal sites are included at the end of Chapter 2 for review. Figures 2.1 and 2.2 depict close up aerial views of the existing failed dams at the East Cape Extension and Homestead canals.
