**BEACH RESTORATION TO PROTECT NC HIGHWAY 12
CLEAN WATER ACT 404 AND NPS SPECIAL USE PERMITS
AT BUXTON, DARE COUNTY, NORTH CAROLINA**

ESSENTIAL FISH HABITAT ASSESSMENT

BEACH RESTORATION TO PROTECT NC HIGHWAY 12 AT BUXTON, DARE COUNTY, NC

April 2015

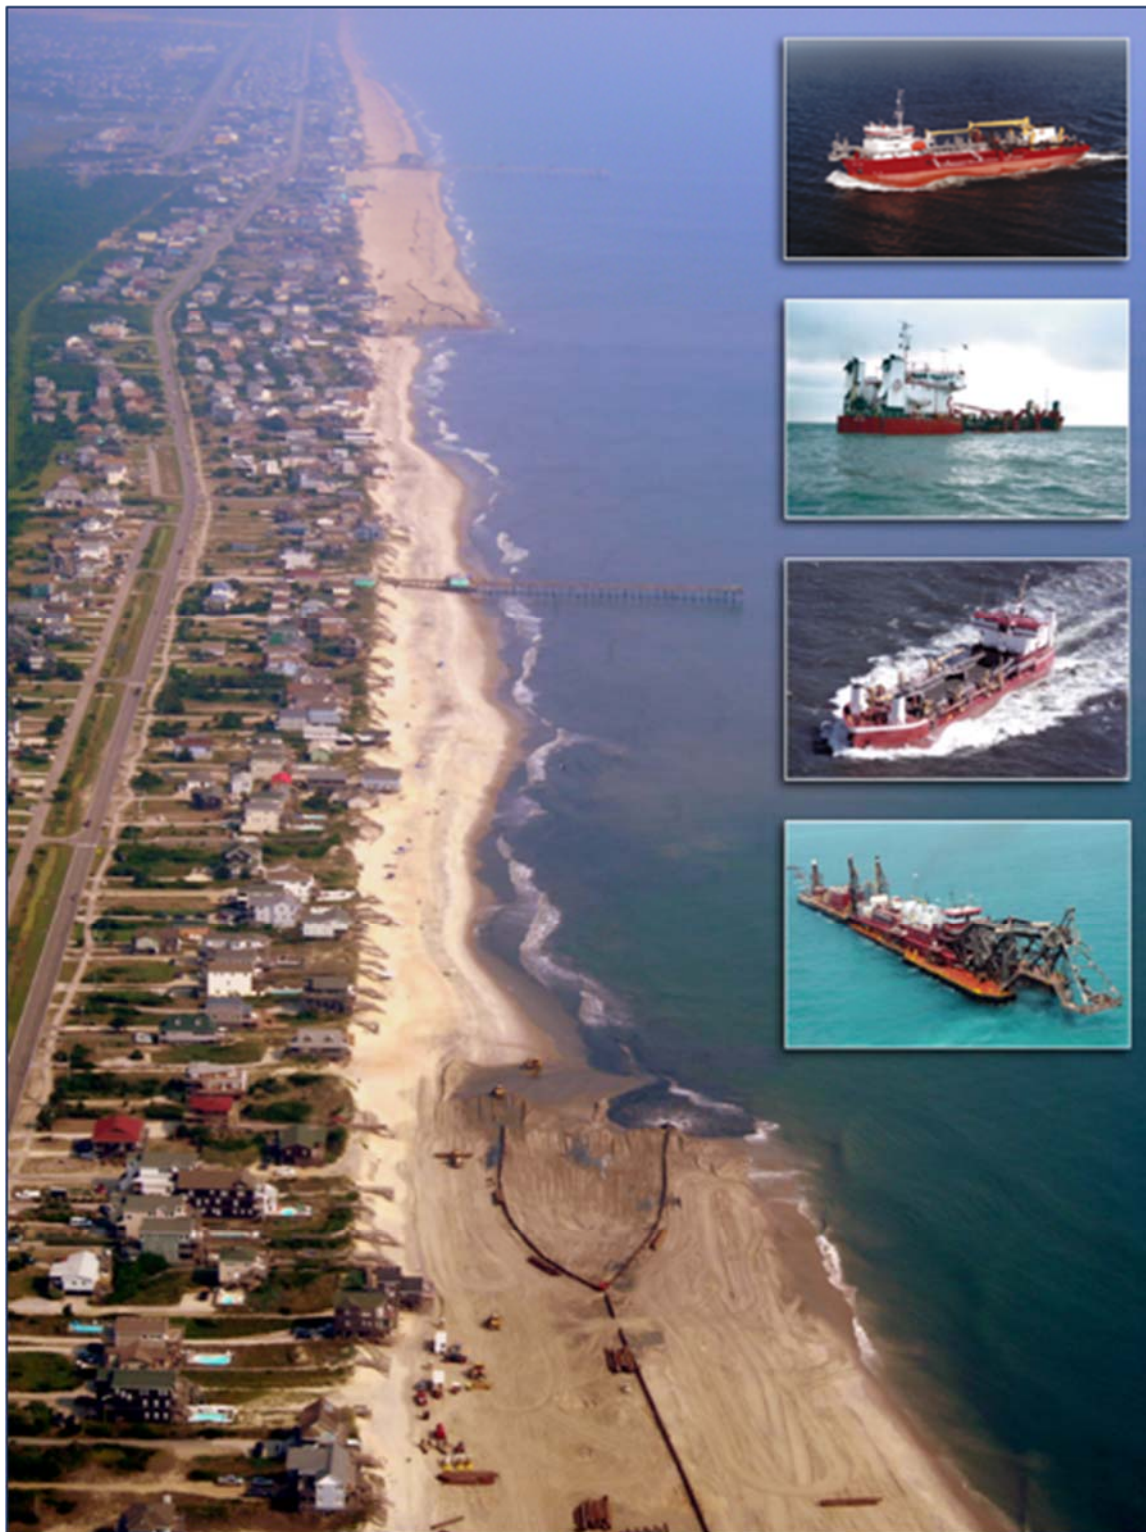
FIGURE 3.6. Three hopper dredges and one suction cutterhead dredge were used to construct the Nags Head (NC) beach nourishment project (24 May to 27 October 2011). Nourishment construction in progress working south to north toward Outer Banks Pier in south Nags Head. [Photos by CSE and Great Lakes Dredge & Dock Co]

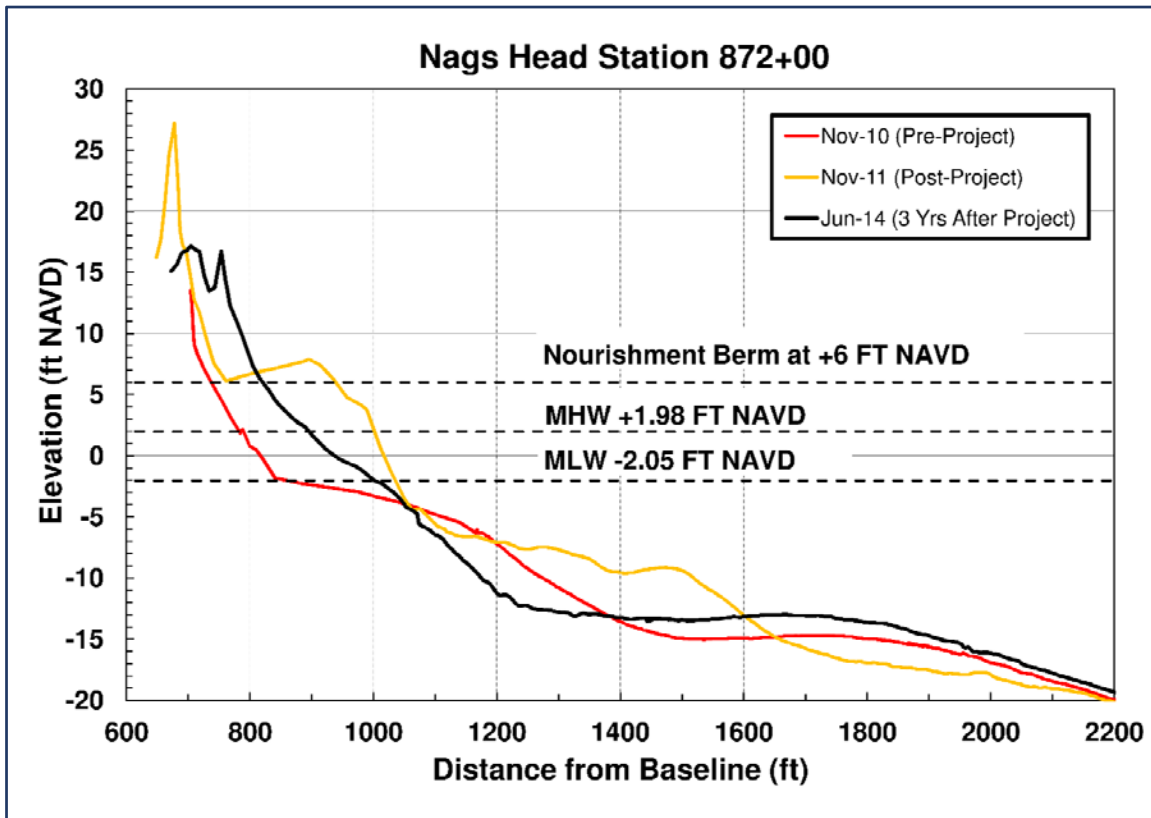
FIGURE 3.9. Pre- and post-nourishment profiles from a station in south Hags Head ~900 ft south of Jennette’s Pier (Whalebone Junction) showing fill adjustment after three years. Note ~20:1 vertical exaggeration. No sand was placed above the +7ft NAVD contour. Natural profile adjustment by Year 3 has included a large shift of sand from the nourishment berm to the fore dune as well as a buildup of sand offshore. The buildup of the fore dune since nourishment is due to natural processes (from CSE 2014). The profile changes include impacts from Hurricane *Irene* (2011) and Hurricane *Sandy* (2012).

7. Loaders will remove and relocate the pipeline and bulldozers will shape the nourishment berm into its final grades and slopes above mean high water. The seaward slope cannot be controlled accurately, but the likely intertidal beach slope for the nourished beach at the time of construction will be ~1 on 15 based on experience in similar settings. The constructed berm is expected to adjust rapidly to slopes and morphology typical of the surf zone, including low-tide bars and troughs formed within weeks in response to varying wave action. During fall months, the project area is subject to frequent high energy wave events associated with minor extra-tropical storms (“northeasters”). The berm elevation of the nourished beach is expected to be lower than the typical wave uprush limit during northeasters and be overtopped periodically within months of project completion. Washover deposits will shift sand landward to higher elevations near the fore dune and shift sand into shallow water. Figure 3.9 illustrates a sequence of profile changes at one station along the Nags Head project area during and shortly after construction (from CSE 2012). Figure 3.10 shows natural buildup of the fore dune over sand fencing placed at the toe of the fore dune one year and three years after construction of the Nags Head project.

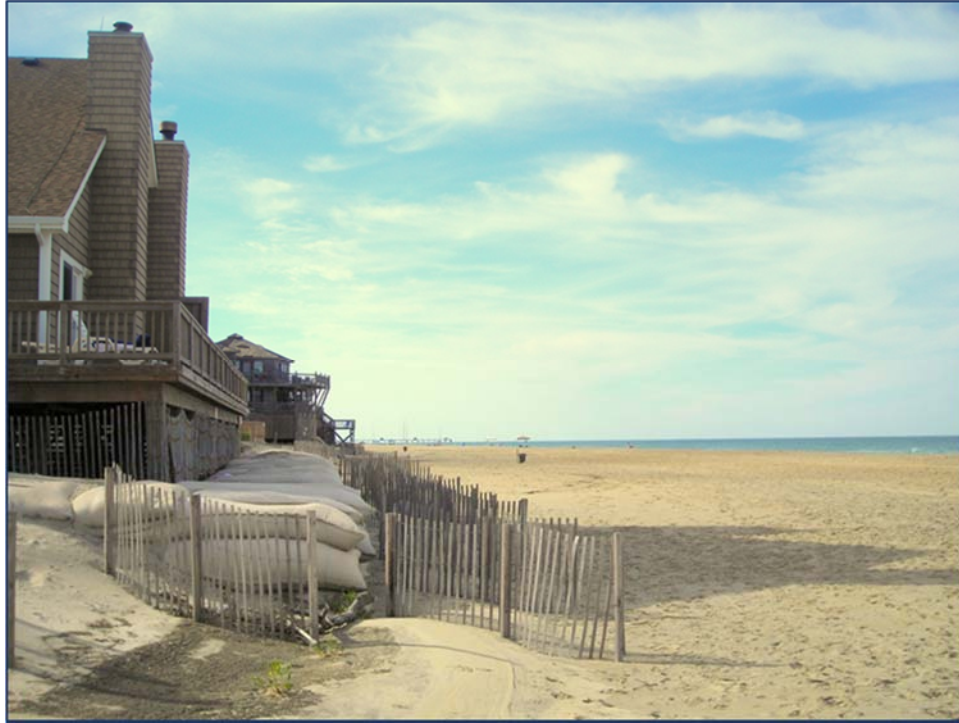
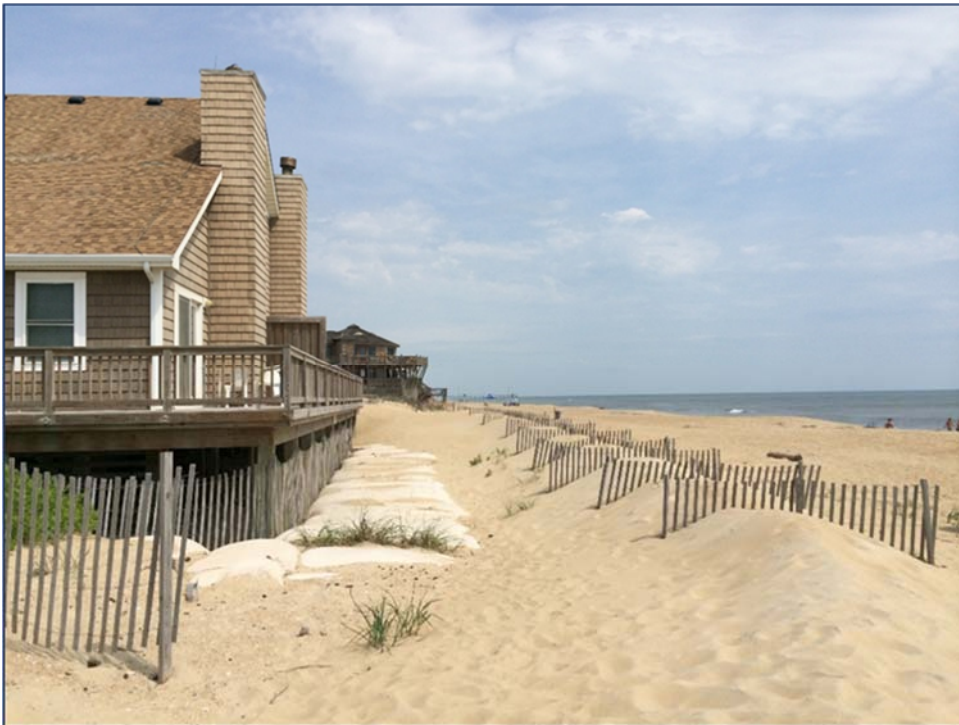
Figure 3.10. Natural dune regrowth along south Nags Head (NH Station 855+00) after the 2011 nourishment project. [UPPER] 11 June 2012 locality in Nags Head (NC) seven months after nourishment. [LOWER] 5 June 2014, same locality two years and seven months after nourishment.
