## Stabilize Hazel Run and Protect Fredericksburg City Sewer Line Manhole Photos

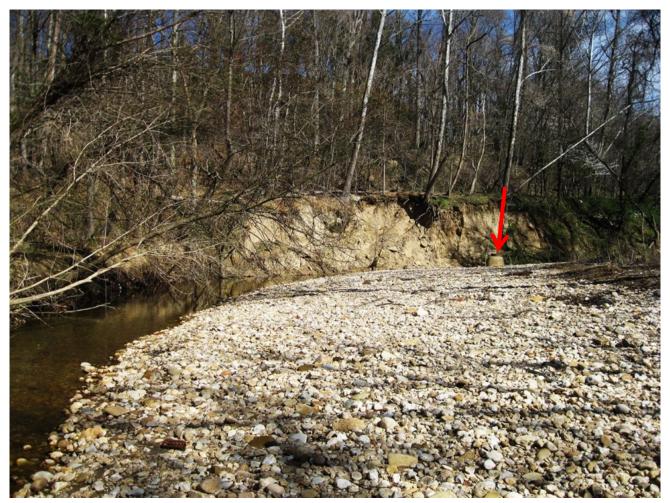
A view downstream along Hazel Run – note the dominant channel to the left, which is eroding the left bank in the distance. The exposed manhole is indicated by the arrow. Rock toe revetment will reinforce the left bank, while gabions and clean backfill will protect the manhole. Two log vanes will be installed in the stream to the left.

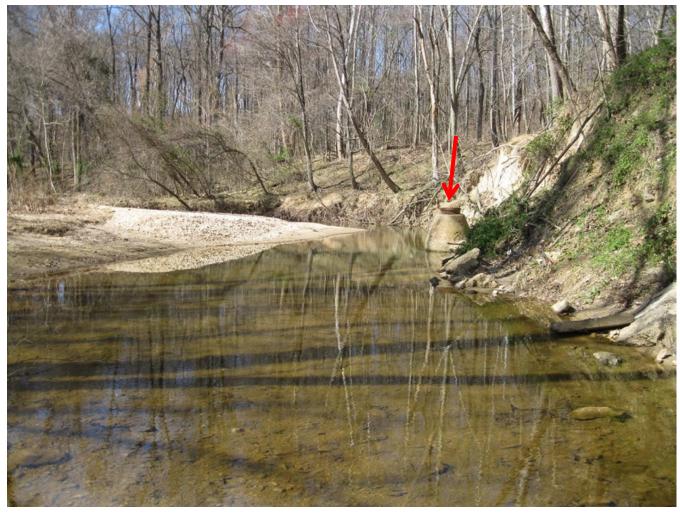
A view upstream along Hazel Run – note the dominant channel to the right, which is eroding the left bank in the distance. The exposed manhole is indicated by the arrow. Rock toe revetment will reinforce the left bank, while gabions and clean backfill will protect the manhole. Two log vanes will be installed in the stream to the left background.

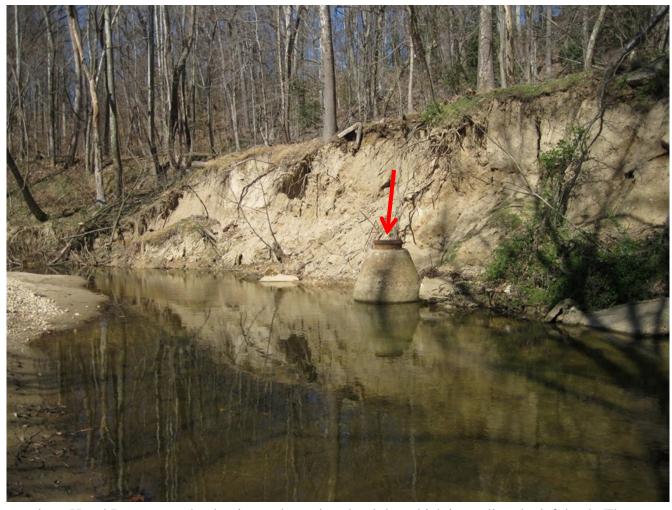
A view upstream along Hazel Run – note the dominant channel to the right, which is eroding the left bank. The exposed manhole is indicated by the arrow. Rock toe revetment will reinforce the left bank, while gabions and clean backfill will protect the manhole. Two log vanes will be installed in the stream out of sight to the left background.

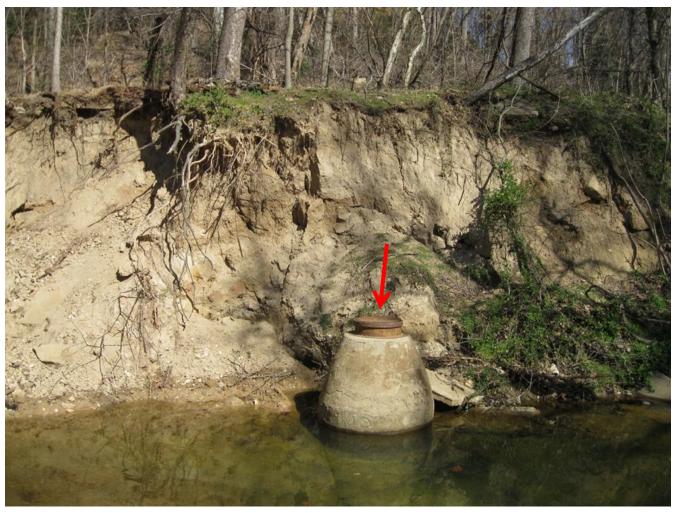
A view of the exposed manhole, indicated by the arrow. Gabions and clean backfill will protect the manhole.
