***Installation of a Well, Chlorination and Septic System, and Restrooms at Ellwood on the
Wilderness Battlefield***
Photos

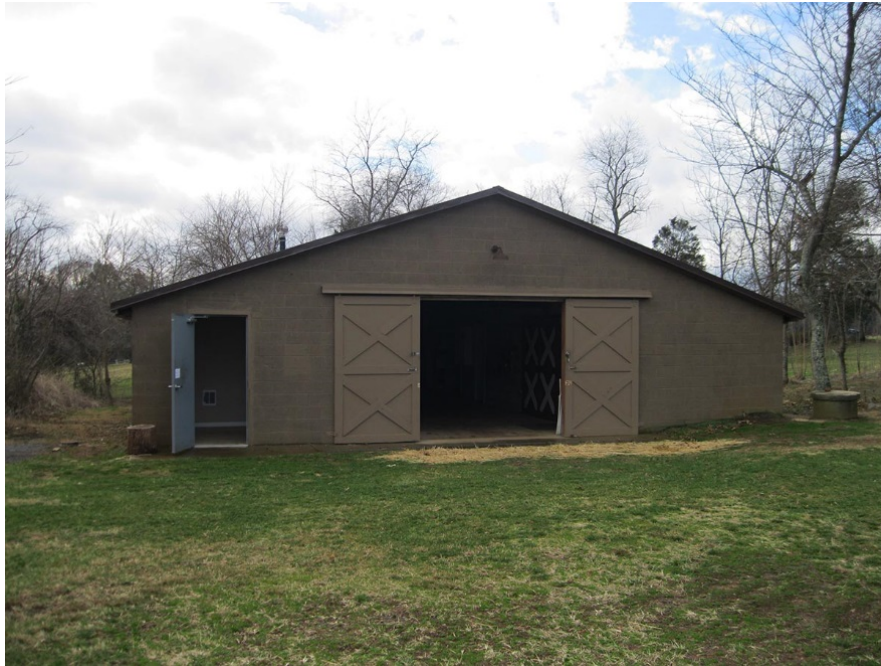
Looking south at the front of the Ellwood Brooder Barn – the existing well, which will be abandoned, is visible off the right corner of the barn. The new well will be installed off the left corner of the building. The door at the left serves the restroom and will continue to serve the two new restrooms.

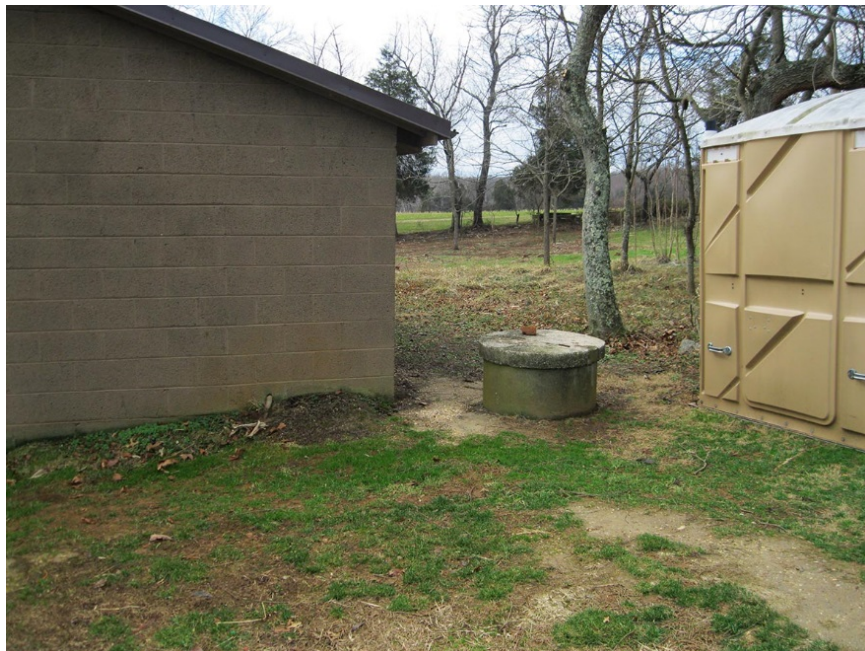
The existing well will be filled and abandoned. The concrete collar will be removed, clean fill added, graded and seeded. The temporary restroom facility will also be removed.

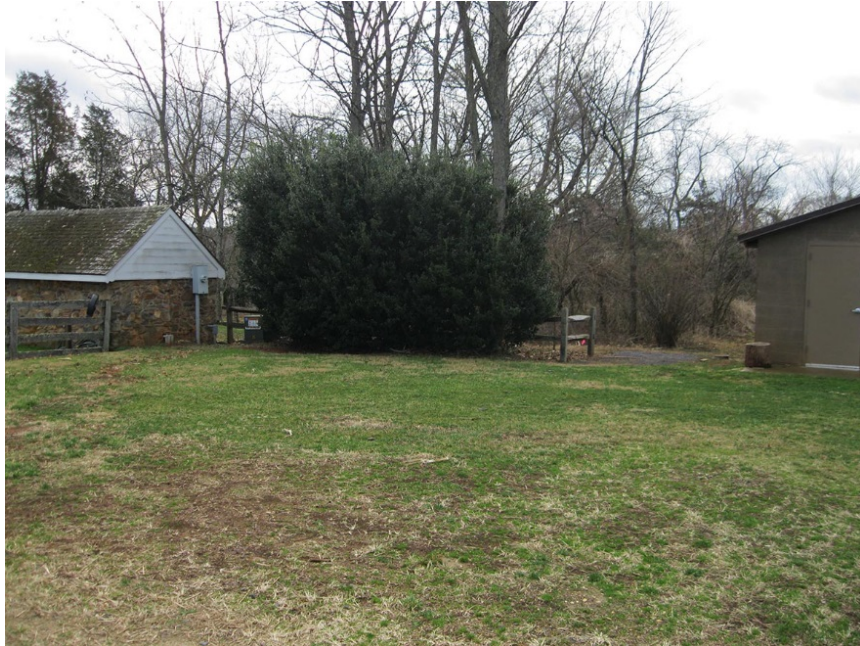
Existing lines between the Farm Office (Pump House) to the left and the Brooder Barn to the right will be replaced.

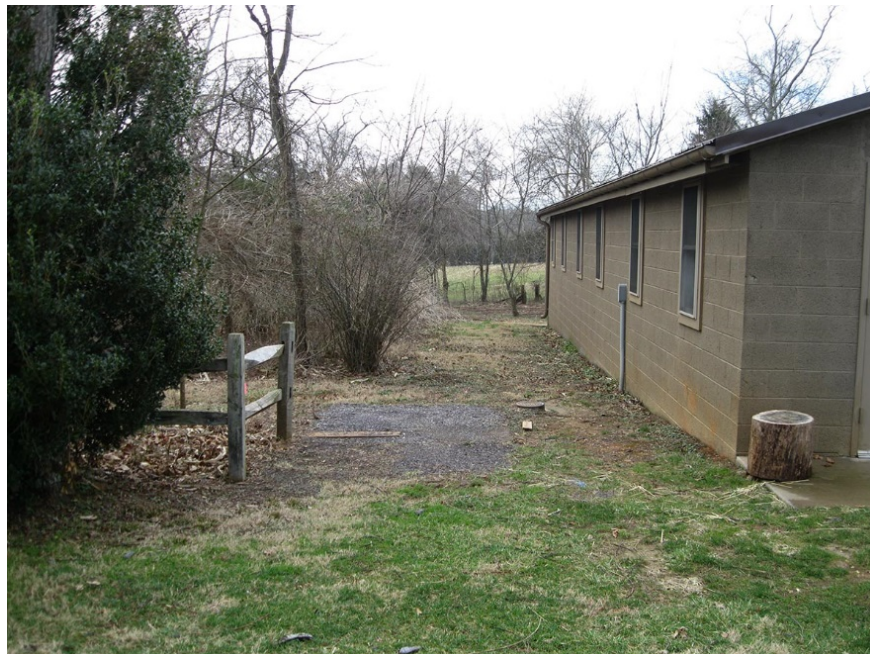
The new well will be installed in the foreground, off the corner of the building. Underground water and sewer lines will be installed the length of the building, accessing the underground septic tank to be installed in the distance.

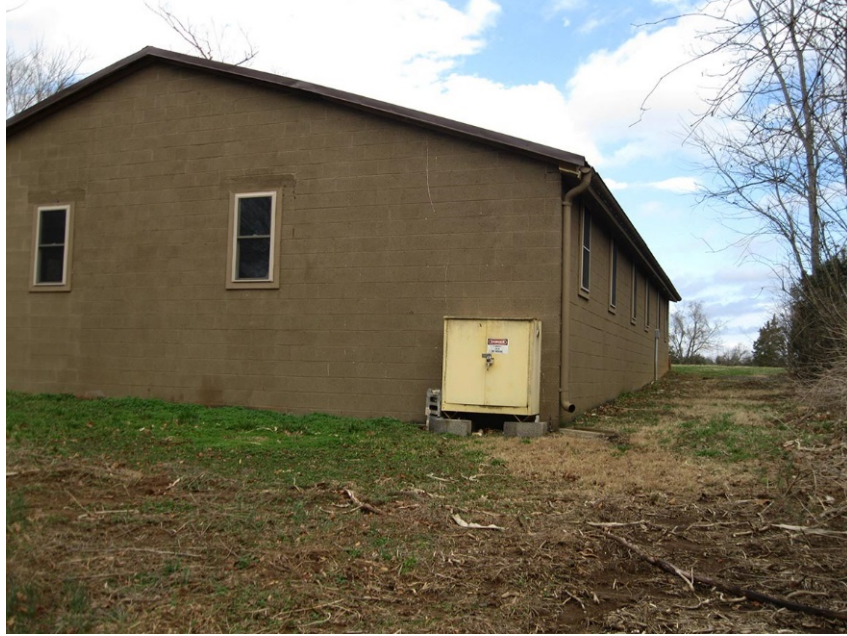
Looking north from the proposed site of the buried septic tank. Underground sewer and water lines will be buried the length of the building, connecting with the new well to be installed in the distance. The metal box on the rear of the Brooder Barn will be replaced with a small generator that will operate the water system, and the fire suppression system, in case of a power outage.

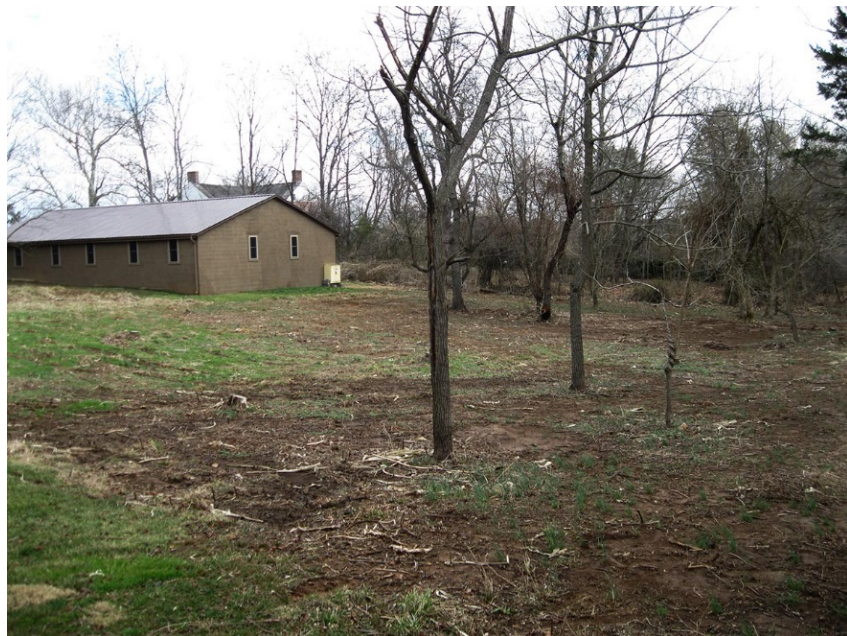
View looking northeast across the cleared area where the drain field will be installed.

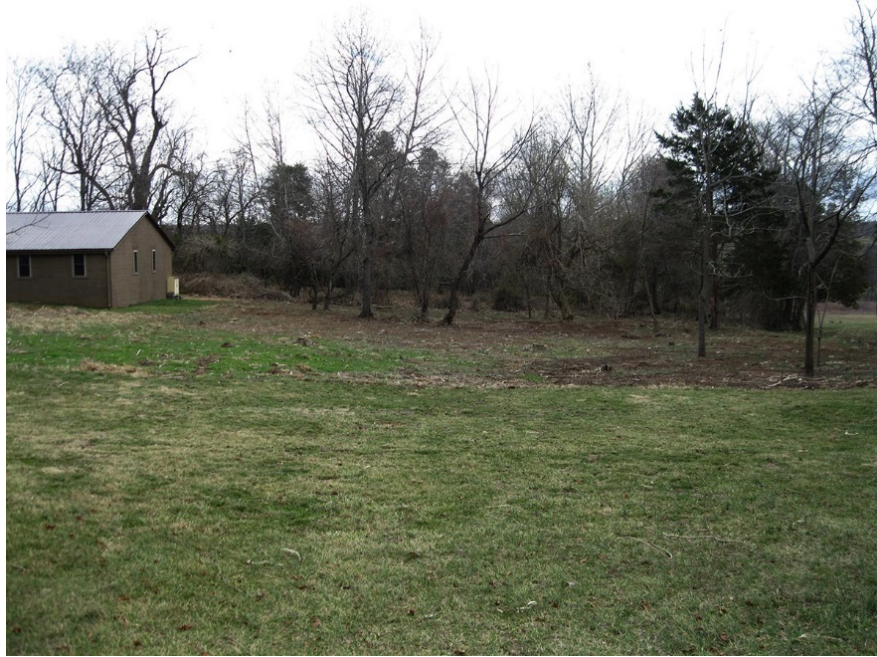
View looking east across the cleared area where the drain field will be installed.

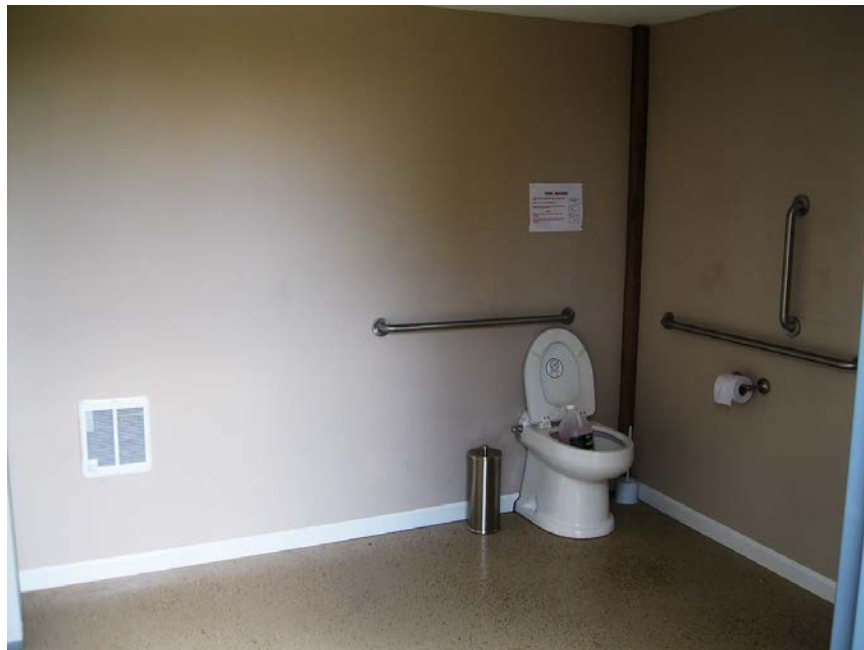
Existing composting restroom facility inside the Brooder Barn. This will be enlarged into two restrooms.

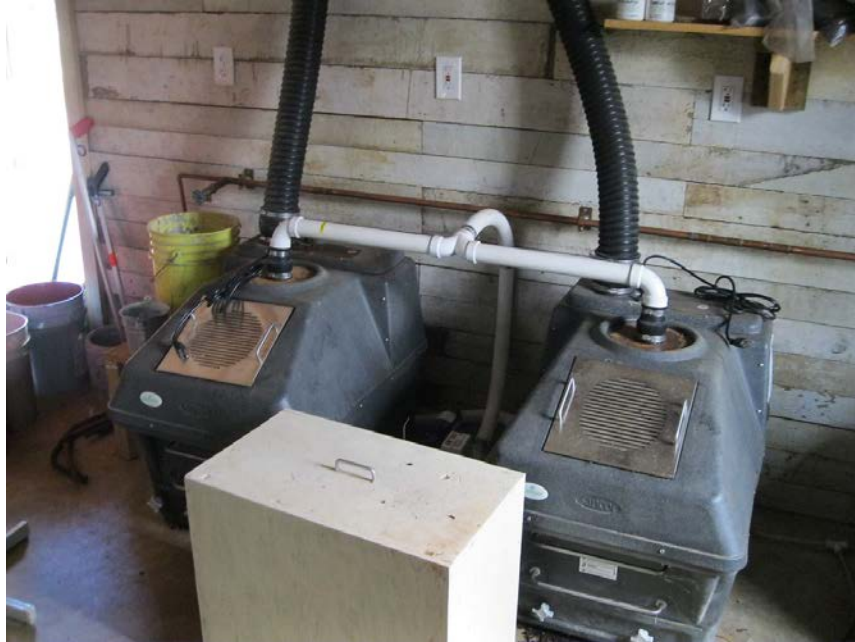
Restroom composting infrastructure inside the Brooder Barn will be removed.

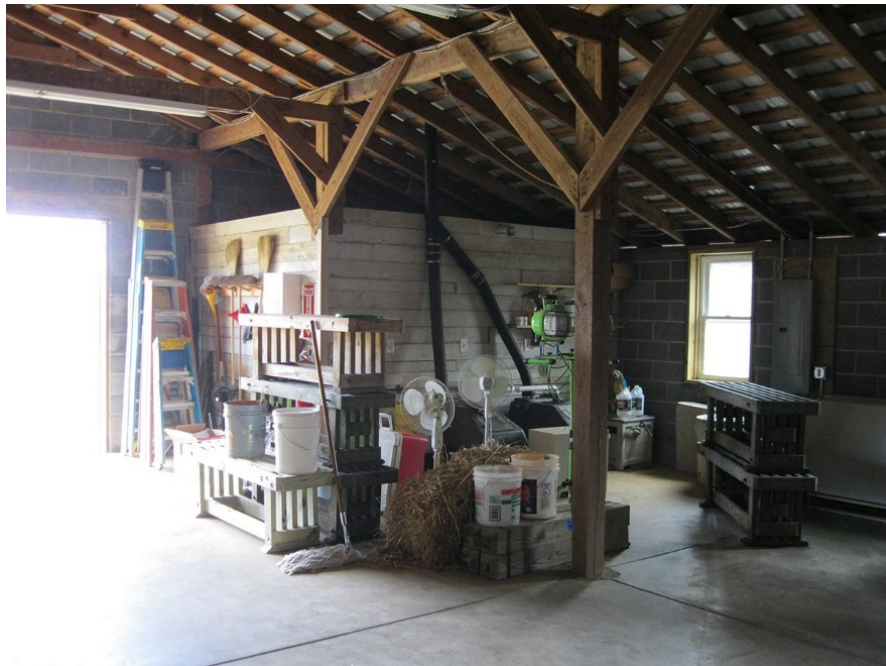
Inside the Brooder Barn looking at the framed out existing restroom. This will be enlarged to create two restrooms connected to the new drain field and septic system.
